Pilot killed in F-86D Sabre jet crash near Holly Michigan remembered

David Trojan, Aviation Archaeologist, davidtrojan@earthlink.net Aug 2016-Jan 2017

F-86D Sabre jet serial #51-8437, crashed December 16, 1954

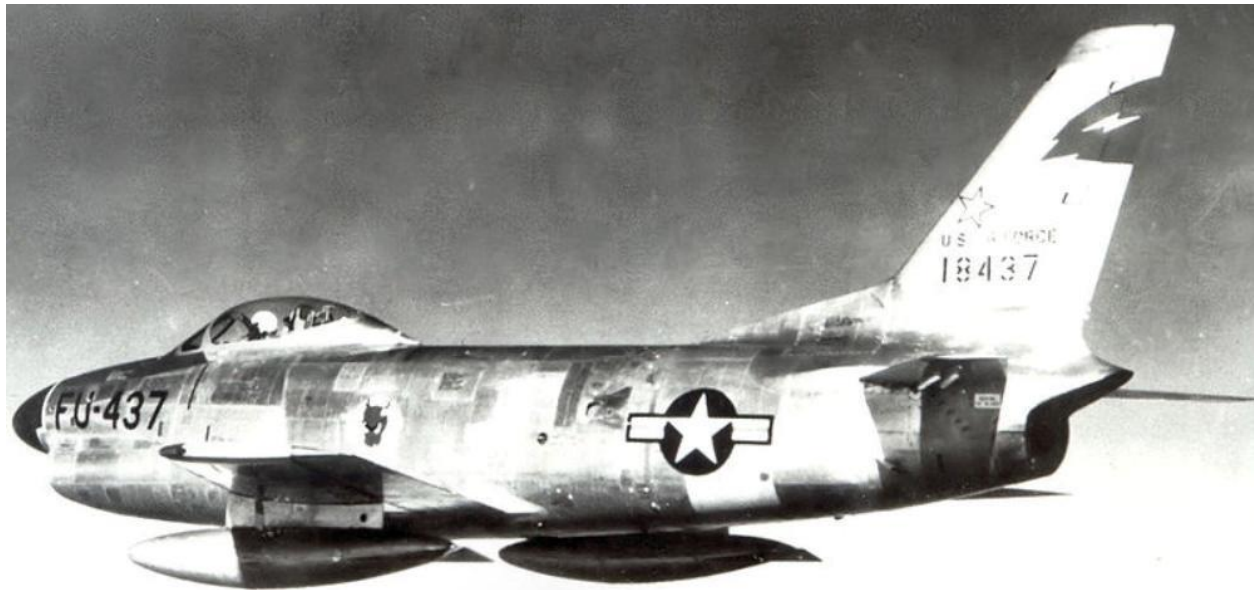
Investigation at the scene of the accident ascertained little, it appeared that the aircraft struck the ground in a nose low left **turn** and exploded upon impact. No evidence of fire before the impact could be found. Therefore it was believed that the aircraft flew into the ground under normal power. With the evidence available, the military accident investigation board was unable to determine the cause of this accident.

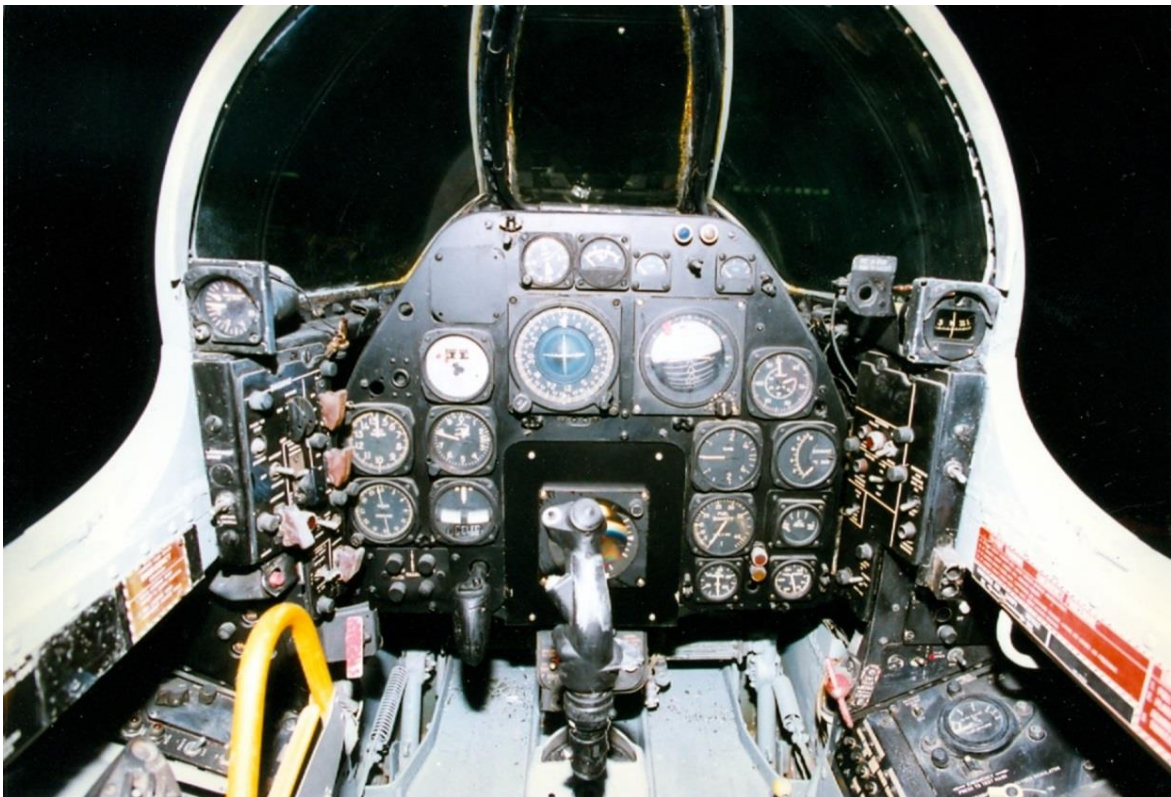
During the go around (180 degree left turn), the pilot was apparently engaged in changing radio frequency channels. The radio channel change necessitated looking down into the cockpit to operate the radio control, distracting the pilot at this critical moment. Pilot distraction was another contributing cause of this accident. The official accident investigation board found that this changing of the radio channels was most likely the major factor of the accident and recommended changes to the location of the radio equipment. However, with the evidence available to them, the board was unable to determine the overall cause of this accident.

F-86D cockpit, note radio controls require looking down and to the side

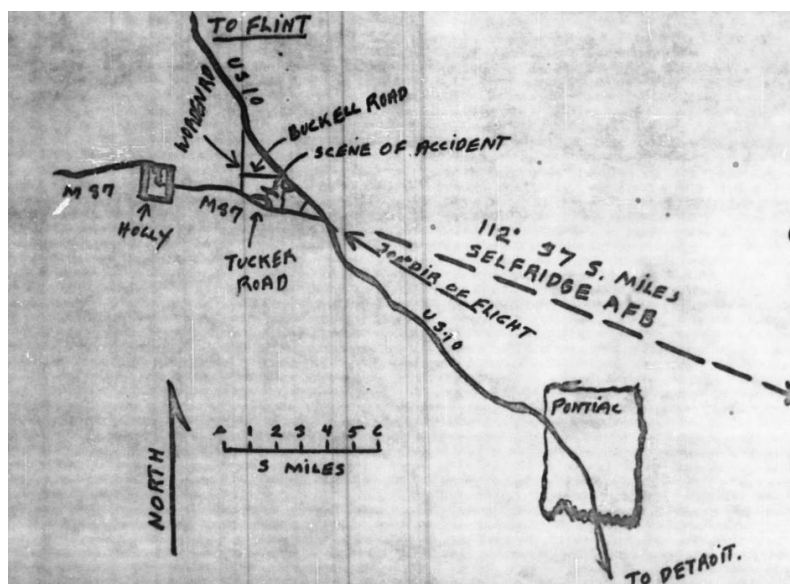
Diagram of accident from the report contained location information

Jeff Benya from Michigan Aviation Archaeology and I set out to try and determine the exact location of the crash site more than 62 years later. The diagram of the accident from the official accident report provided clues about the location of the crash. However, it was not detailed enough and more than 60 years had passed since it was drawn. The area is now heavily forested and a major highway, I-75 cuts through the property. The local newspapers provided better location information. The Holly Michigan Newspaper stated that the crash occurred on the 160 acre farm of Emil Perlick and even gave an address. According to plat maps of the time, Emil Perlick owned two 80 acre parcels in the area. Jeff completed an outstanding analysis using Google Earth images. Overlays of the area using 1950 aerial images onto current Google Earth images were used to narrow down the search area.

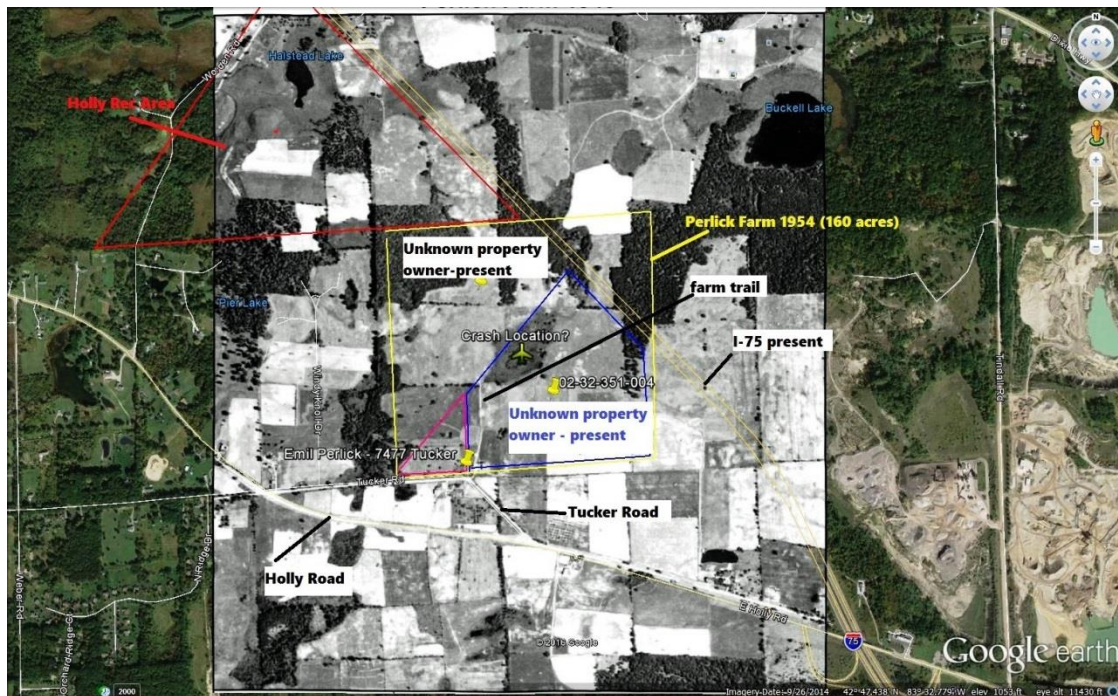
A Google Earth overlay using the plat maps shows where Perlick's property would be today – a mostly wooded area with a small lake/swamp area in the middle of it, bisected by a high voltage right of way. The high voltage lines went in between 1974 and 1980 (based on historical aeriels) and could have covered the crash site. Furthermore, Highway I-75 was built through the NE corner of the property between 1960 and 1963 and could have also covered the crash site. Perlick's house was still on the property and according to his witness statement; he estimated that the crash occurred ½ mile from his house. Perlick's original 160 acres appears to have been split into five properties: Perlick's house, 7477 Tucker, and two more houses to his west have normal residential size lots. The rest is split into two large wooded lots divided by the swamp area. Based on historical imagery, the swamp area has been around since at least 1940 and appears to be much wetter today than back in the day. Aerials from 1940-1963 show a farm road from Perlick's house directly to the swamp area and if you look closely on G.E. one can still see remnants of the road on current images, this could be how they got back to the crash scene in 1954.

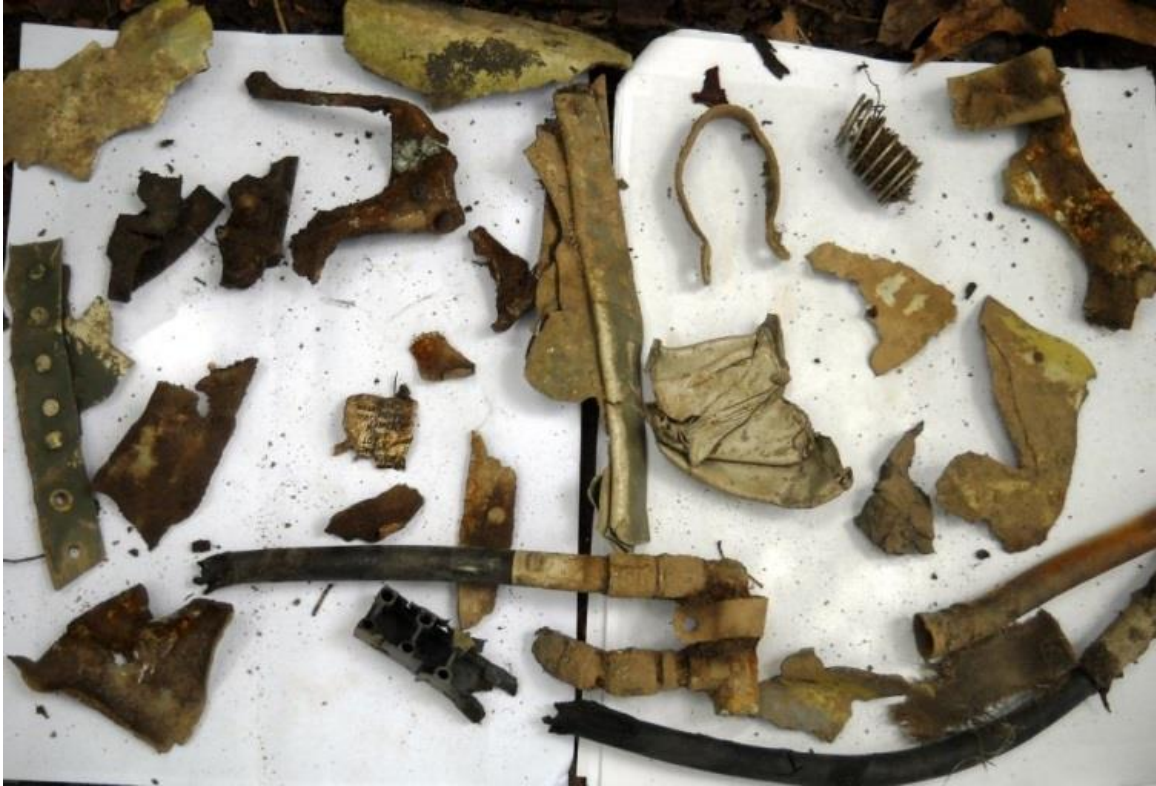
Aircraft artifacts discovered at the crash site

The crash site is located very near the edge of open water. The report has the impact being in the water (ice at the time of the crash). The report pics show a group of 4-5 trees on the edge of the swamp and nothing but fields. The fields have now grown into dense woods with thick underbrush. We searched the area long enough to discover a few pieces of the aircraft. According to the report, the engine is still under water in the swamp because it was never recovered. We found lots of small stuff right on the edge of the swamp. One piece was labeled as the pitot machmeter, it was from the hose line that goes to the pitot tube. We photographed what we found and left the artifacts at the site. Before we left the site, we had a short memorial service for the pilot.

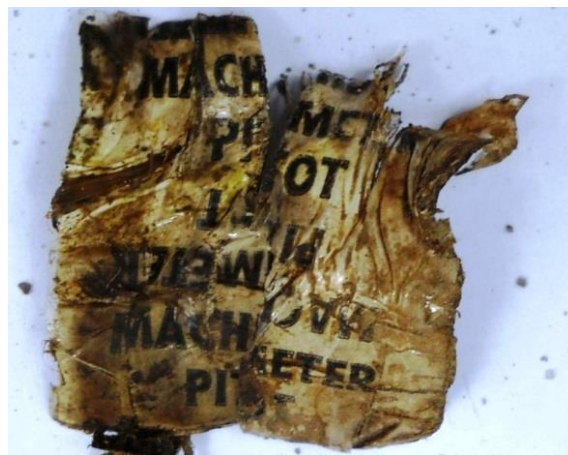
Machmeter label from pilot tube line
