P-3A Orion 152159 Accident Investigation

David Trojan, davidtrojan@earthlink.net

June 2007, updated August 2015

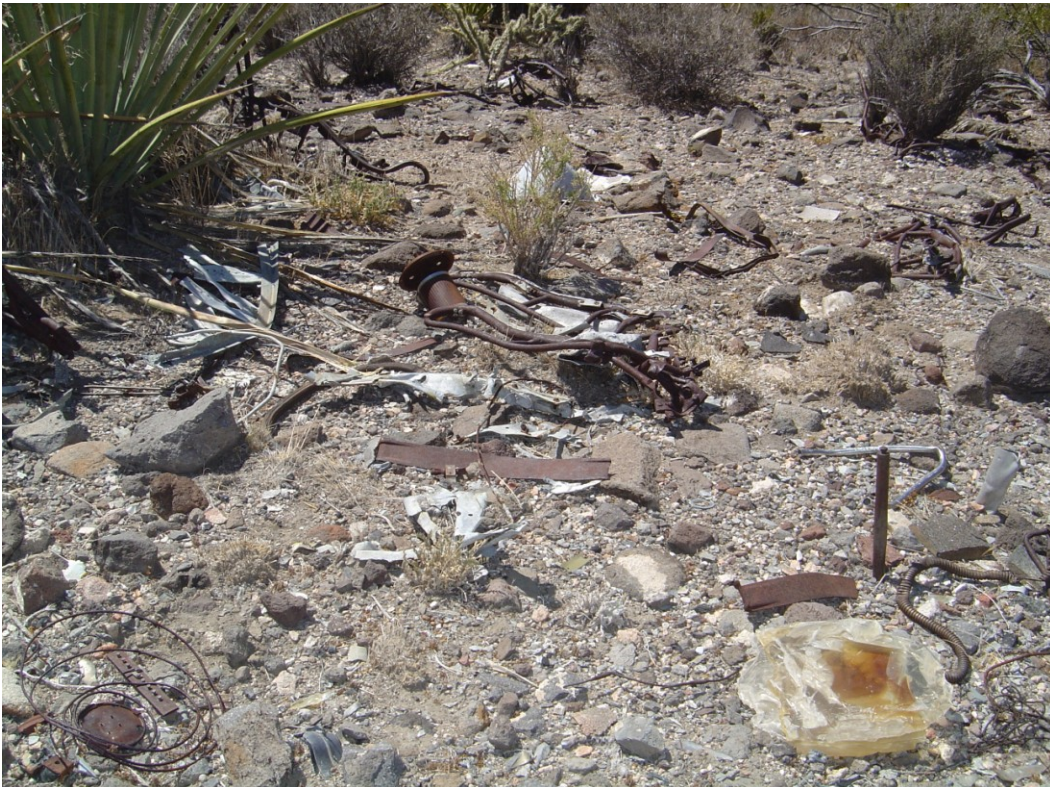
Scattered wreckage at the main impact site, photo by Dave Trojan

Wreckage is scattered over a mile and a half across the desert floor according to the accident report. I explored the main impact area that included the center crew compartment section of the wreck. By looking at the site wreckage, it definitely looked like the aircraft broke up in flight and was burning at the time it fell to the ground. Splattered aluminum droplets were found on some rocks as evidence of the in-flight breakup. I found it strange that the crash site still contained a number of crew seats, steel aircraft parts, parachutes, fabric, and fiberglass, but little aluminum fragments. The aluminum must have been picked up by the recovery crew or aluminum scavengers. Interesting things found at the wreck site included an unbroken vacuum tube and an ASW equipment dial. The largest piece found was an engine nacelle. It made me wonder what else is out there undiscovered in the desert.

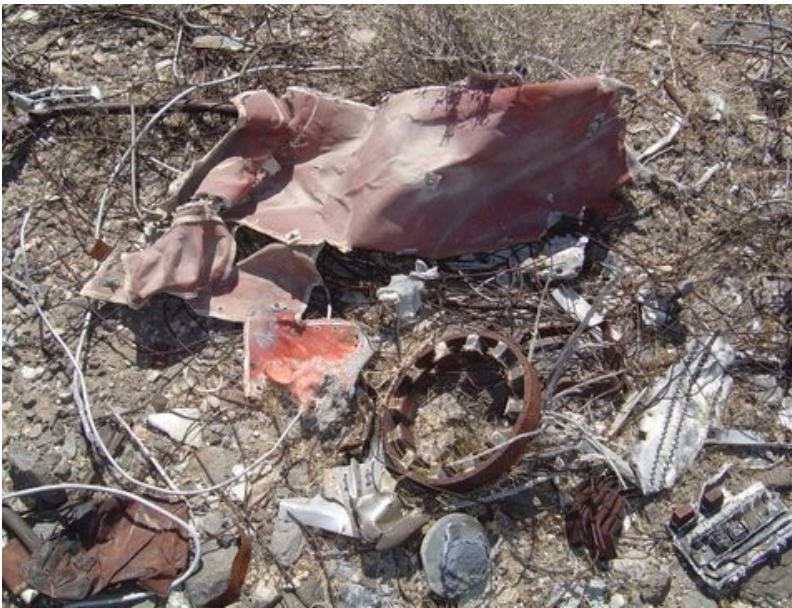
Scattered parts near the main impact site, photo by Dave Trojan

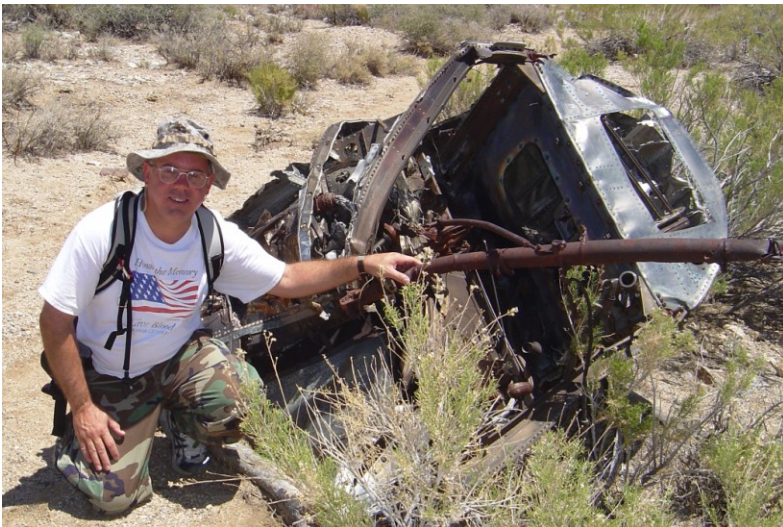
#1 or #4 engine nacelle at the crash site
