The Box in the Barn

By David Trojan, davidtrojan@earthlink.net

Sept 2016

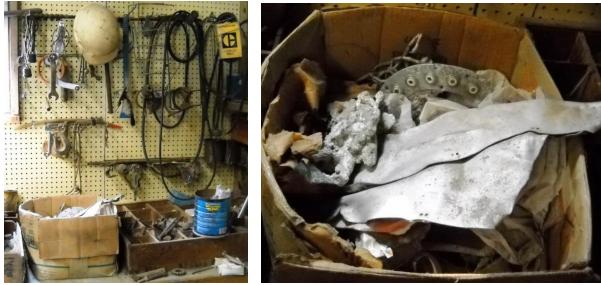
The box in the barn

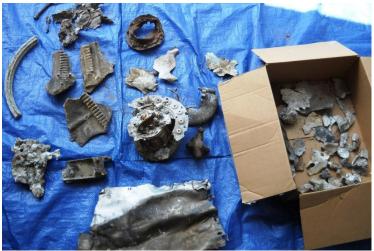
Examining the contents of the box

The challenge with this investigation was trying to identify which aircraft had crashed at the location. When I visited the homestead, I closely examined each and every object in the box. I could tell right away that they were parts from a WWII aircraft due to the type of metal and construction. The collection contained mangled and burned fragments of fuselage skin and other aircraft debris.

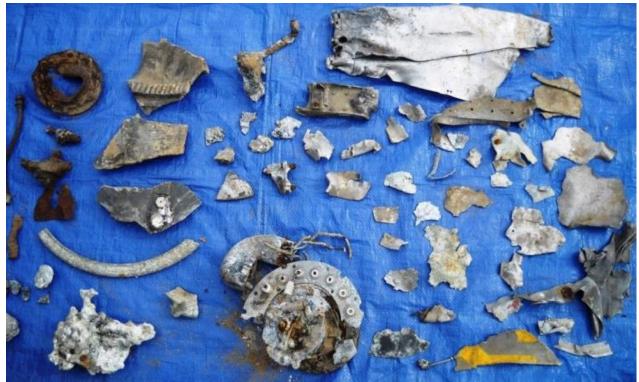
Aircraft parts and fragments that were in the box

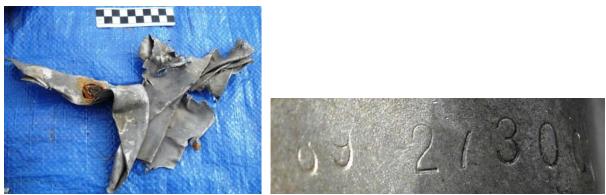
Piece of aircraft that contained part number

Only one mangled piece contained a part number, 89 27300. Using this one piece, I was able to identify the type of aircraft. The first two numbers on the part were 89 indicating a Republic P-47D Thunderbolt fighter aircraft. The P-47 was designed around the powerful Pratt & Whitney R-2800 Double Wasp engine. The P-47 was one of the main United States Army Air Corps fighters of World War II. More than 15,600 Thunderbolts were manufactured between 1941 and 1945 and they served in every theatre of the war performing a variety of missions from bomber escort to close air support. Beginning in July 1944, the P-47 Thunderbolt was also used extensively to train Free French Air Force pilots at the nearby Oscoda Army Air Field (AAF). Now the question was which P-47D had crashed on the property? At least thirty French piloted P-47 aircraft accidents were reported at Oscoda AAF during the time period and resulted in at least four pilots killed.

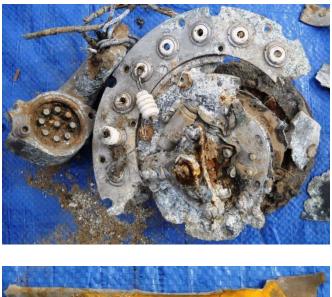
I could tell that most of the parts were from the engine, because I could identify engine case fragments and a large piece of an 18-cylinder, Pratt & Whitney R-2800 Double Wasp engine magneto. Each insulator point was labeled with a number from left to right: 1, 12, 5, 16, 9, 2, more numbers were broken off from part.

Engine magneto

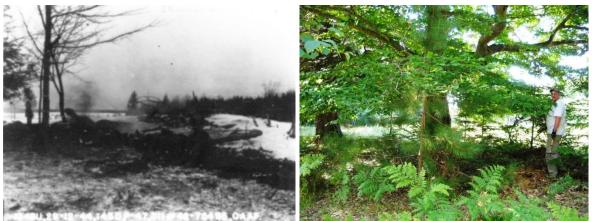
Then and now P-47D, 42-75495, crash site photo comparison

Evergreen tree on the left and another tree on the right next to impact point match where artifacts were found, Jeff Benya standing at approx. impact point

After examining the artifacts in the box, I headed out to the crash site. It was very difficult to match up the original accident report photos with the present day because so many trees had grown up in the area and because the original photos were taken during winter and it was summer when I took my photos. However, the trees in the background of the first photo did match fairly well. The trees are much larger now, but their position is approximately correct in the comparison with an evergreen tree on the left and another tree on the right. I searched the area with a metal detector and discovered more aircraft pieces to add to the box.

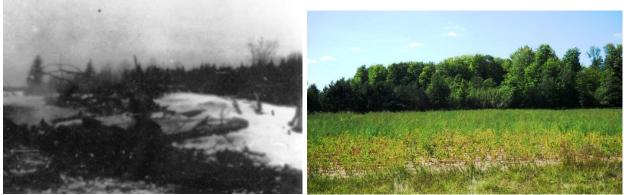
Background tree line matched up fairly well

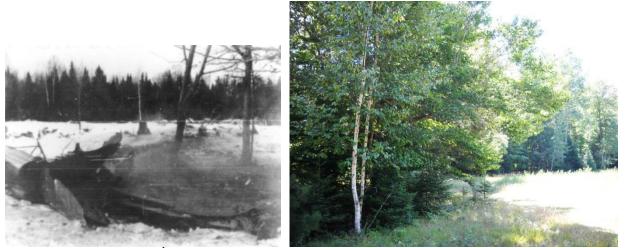
I could not match 2nd report photo because there are now too many trees in the area and the difference between winter and summer photos
