Pilot killed in F-86D Sabre jet crash near Holly Michigan remembered

David Trojan, Aviation Archaeologist, davidtrojan@earthlink.net Aug 2016-Jan 2017

F-86D Sabre jet serial #51-8437, crashed December 16, 1954

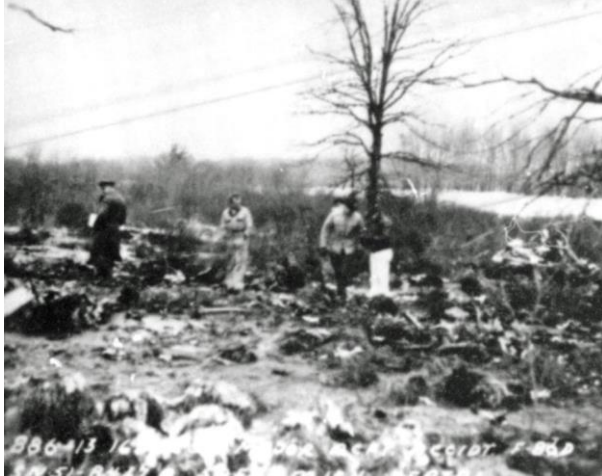
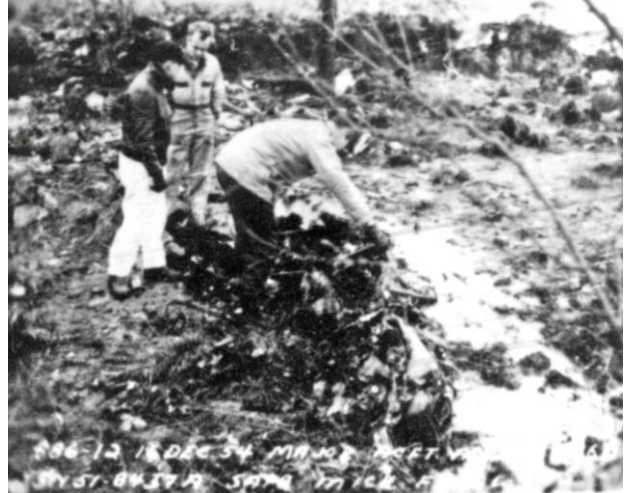
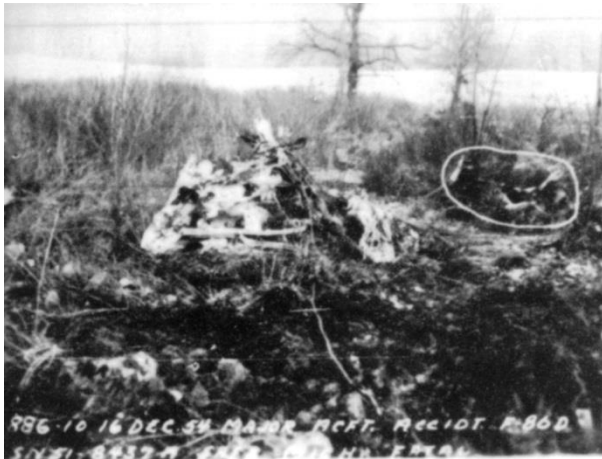
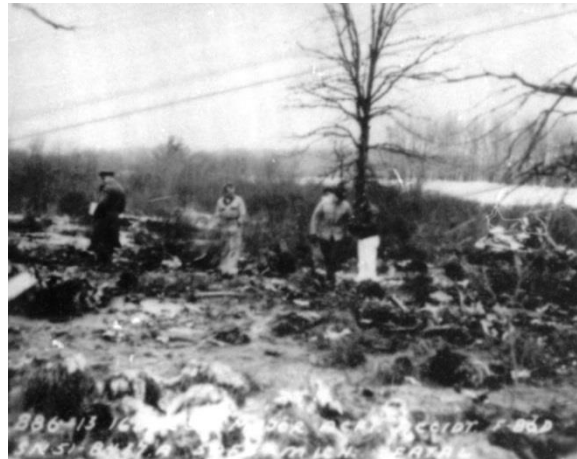
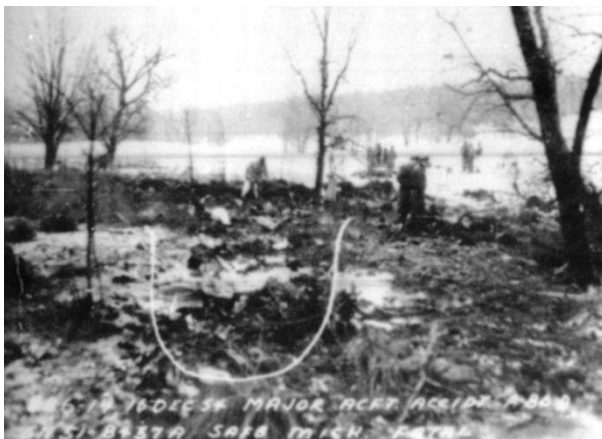
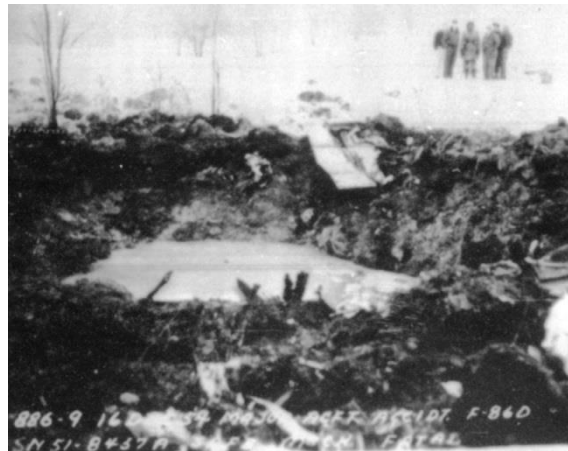
The official accident report contained a number of grainy black and white photographs that we could try and use to locate the crash site. Unfortunately they were taken during winter when the trees were bare and snow covered the ground. We were going in the middle of summer and the terrain looked a lot different more than 60 years later.

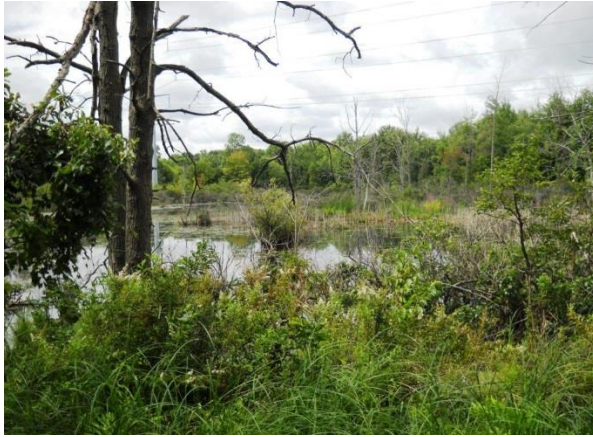
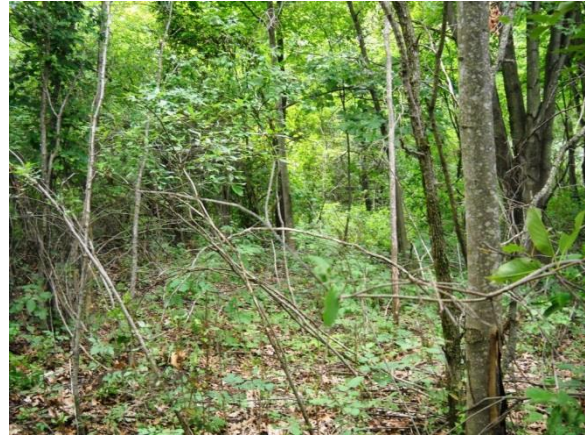
The crash site area August 2016
